Title: RECLAMATION AND CLOSURE PLAN WASTE ROCK BUTTRESS LIFT CONSTRUCTION AND RECLAMATION		
Project: ROSEMONT COPPER	Project no.: 320614	Figure no.:
Location: PIMA COUNTY, ARIZONA	Date: 01/08	17

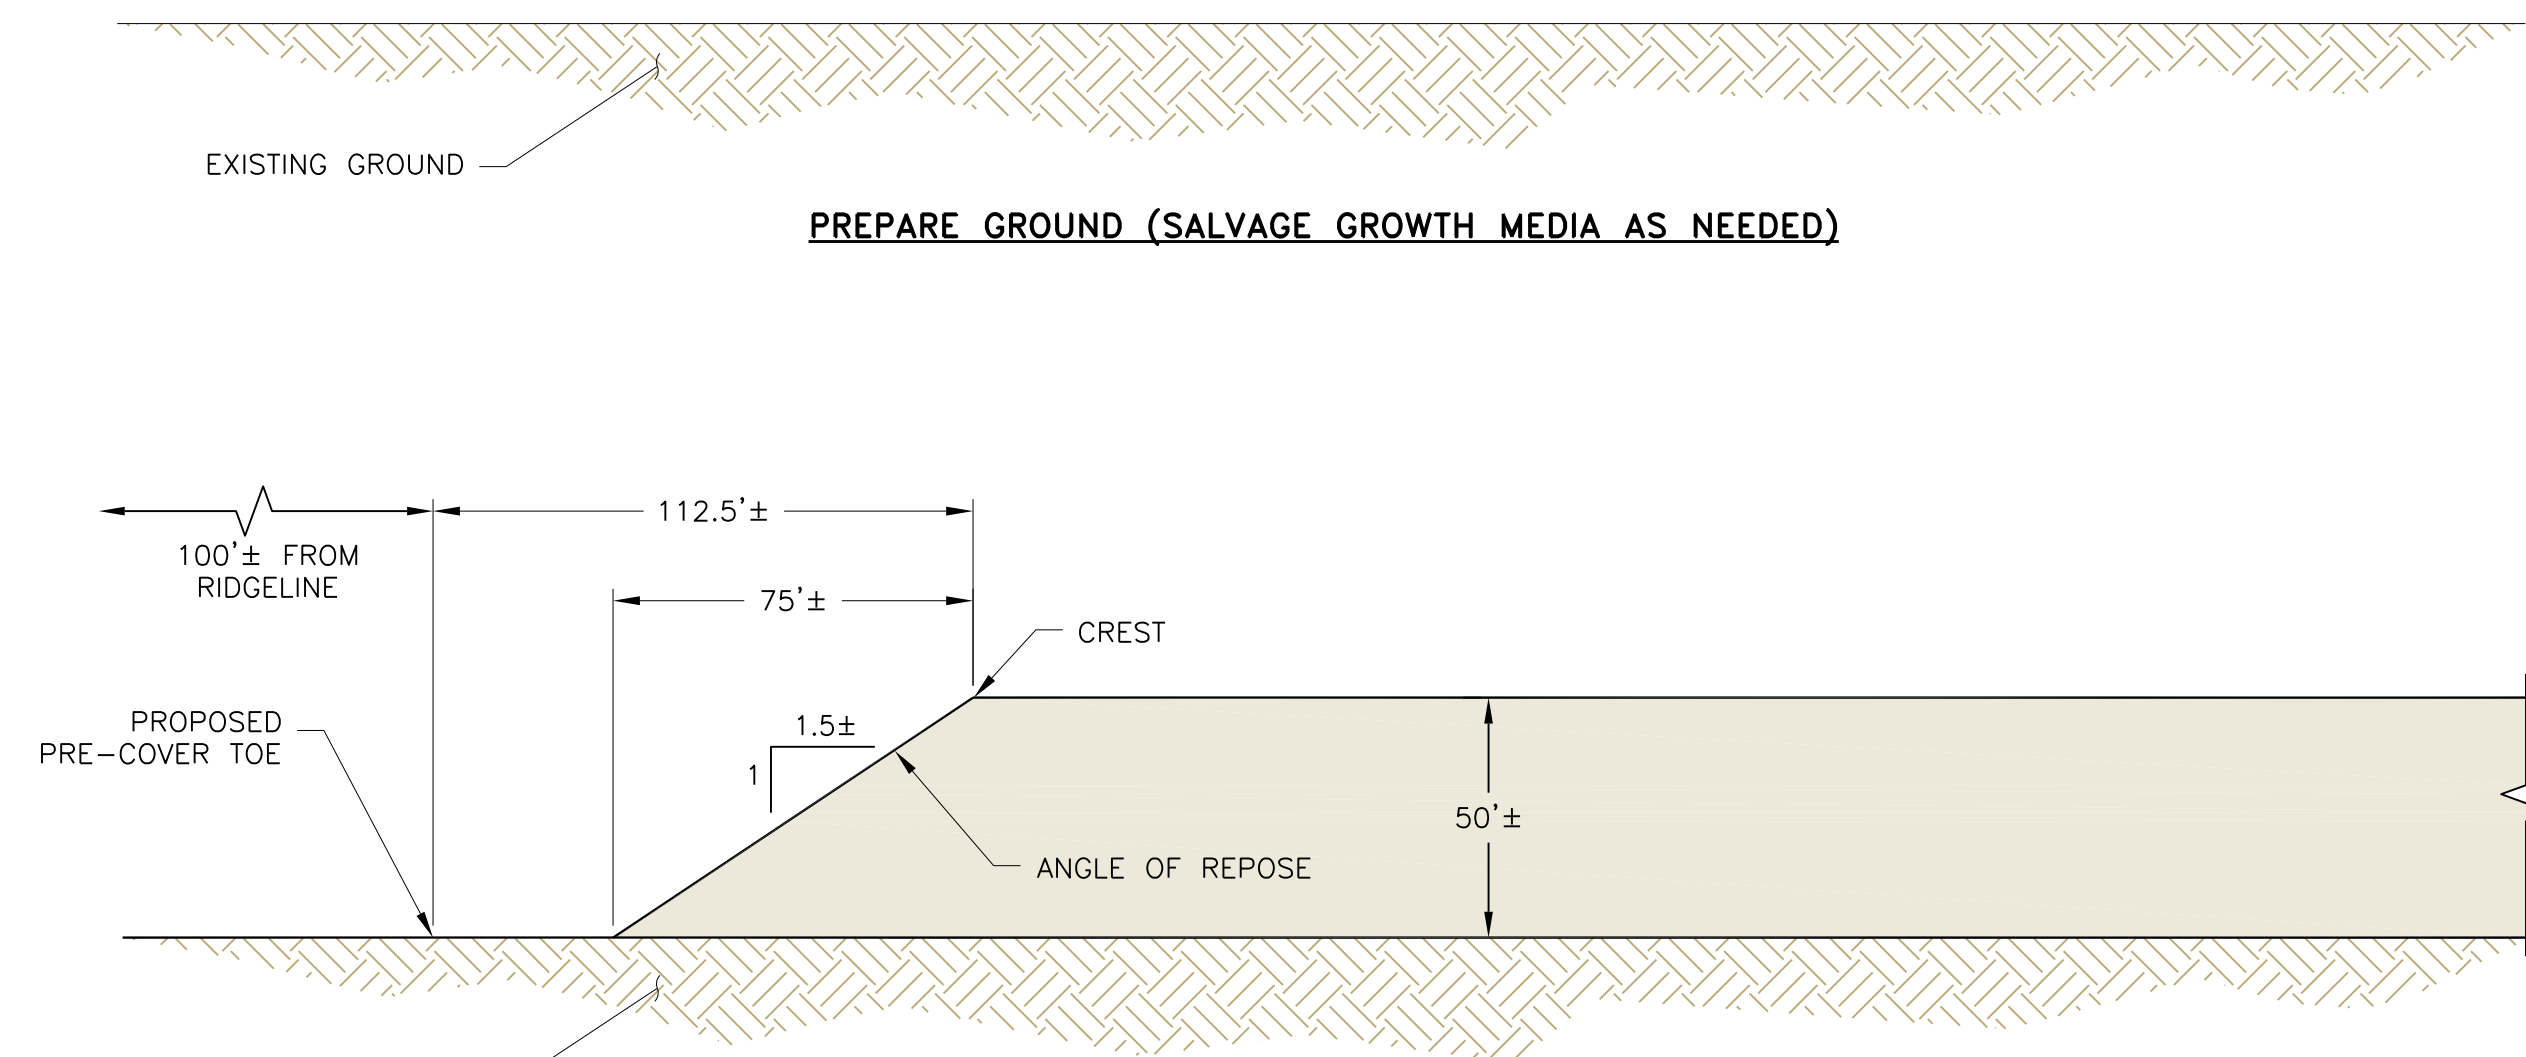
PREPARE GROUND (SALVAGE GROWTH MEDIA AS NEEDED)

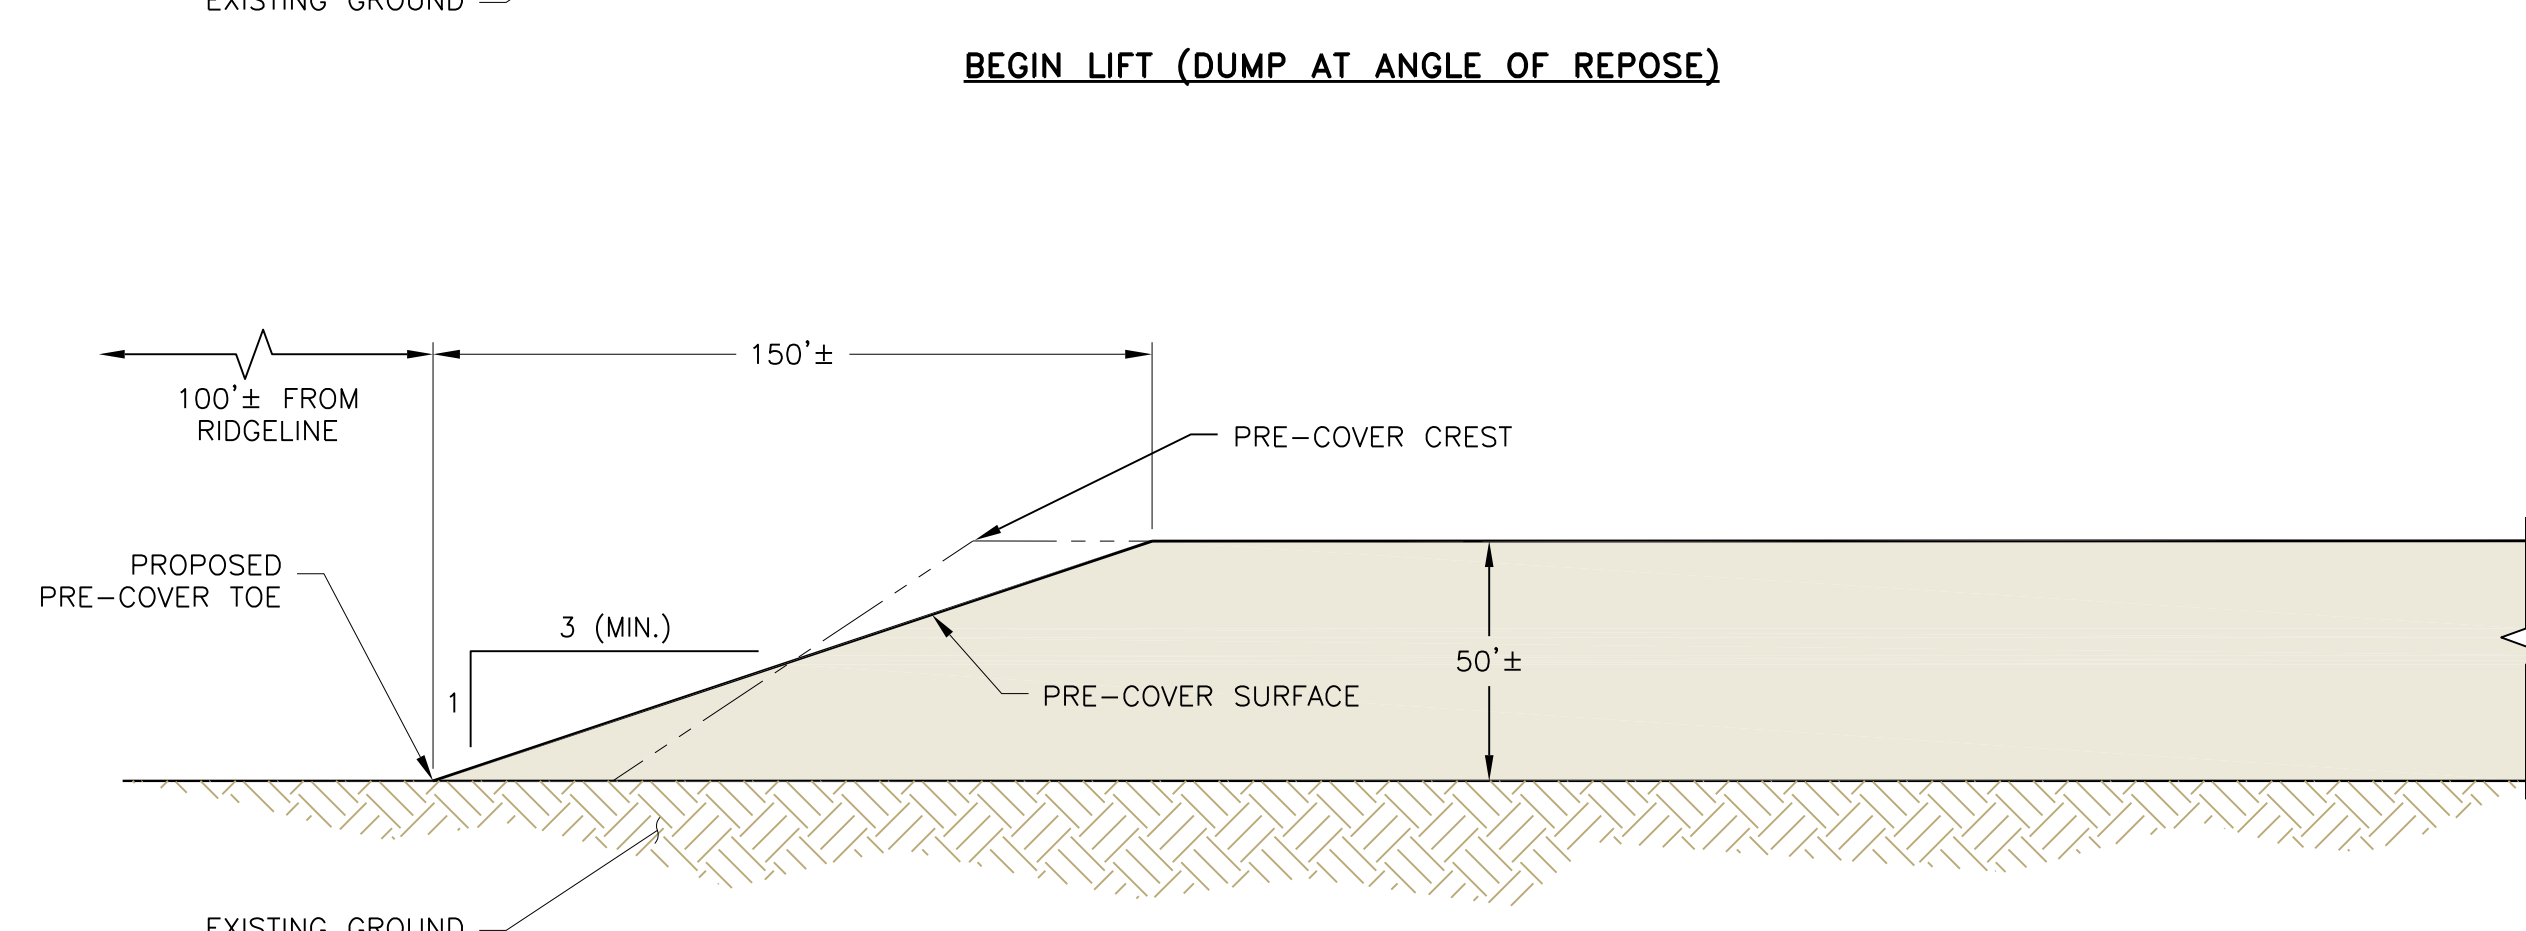
BEGIN LIFT (DUMP AT ANGLE OF REPOSE)

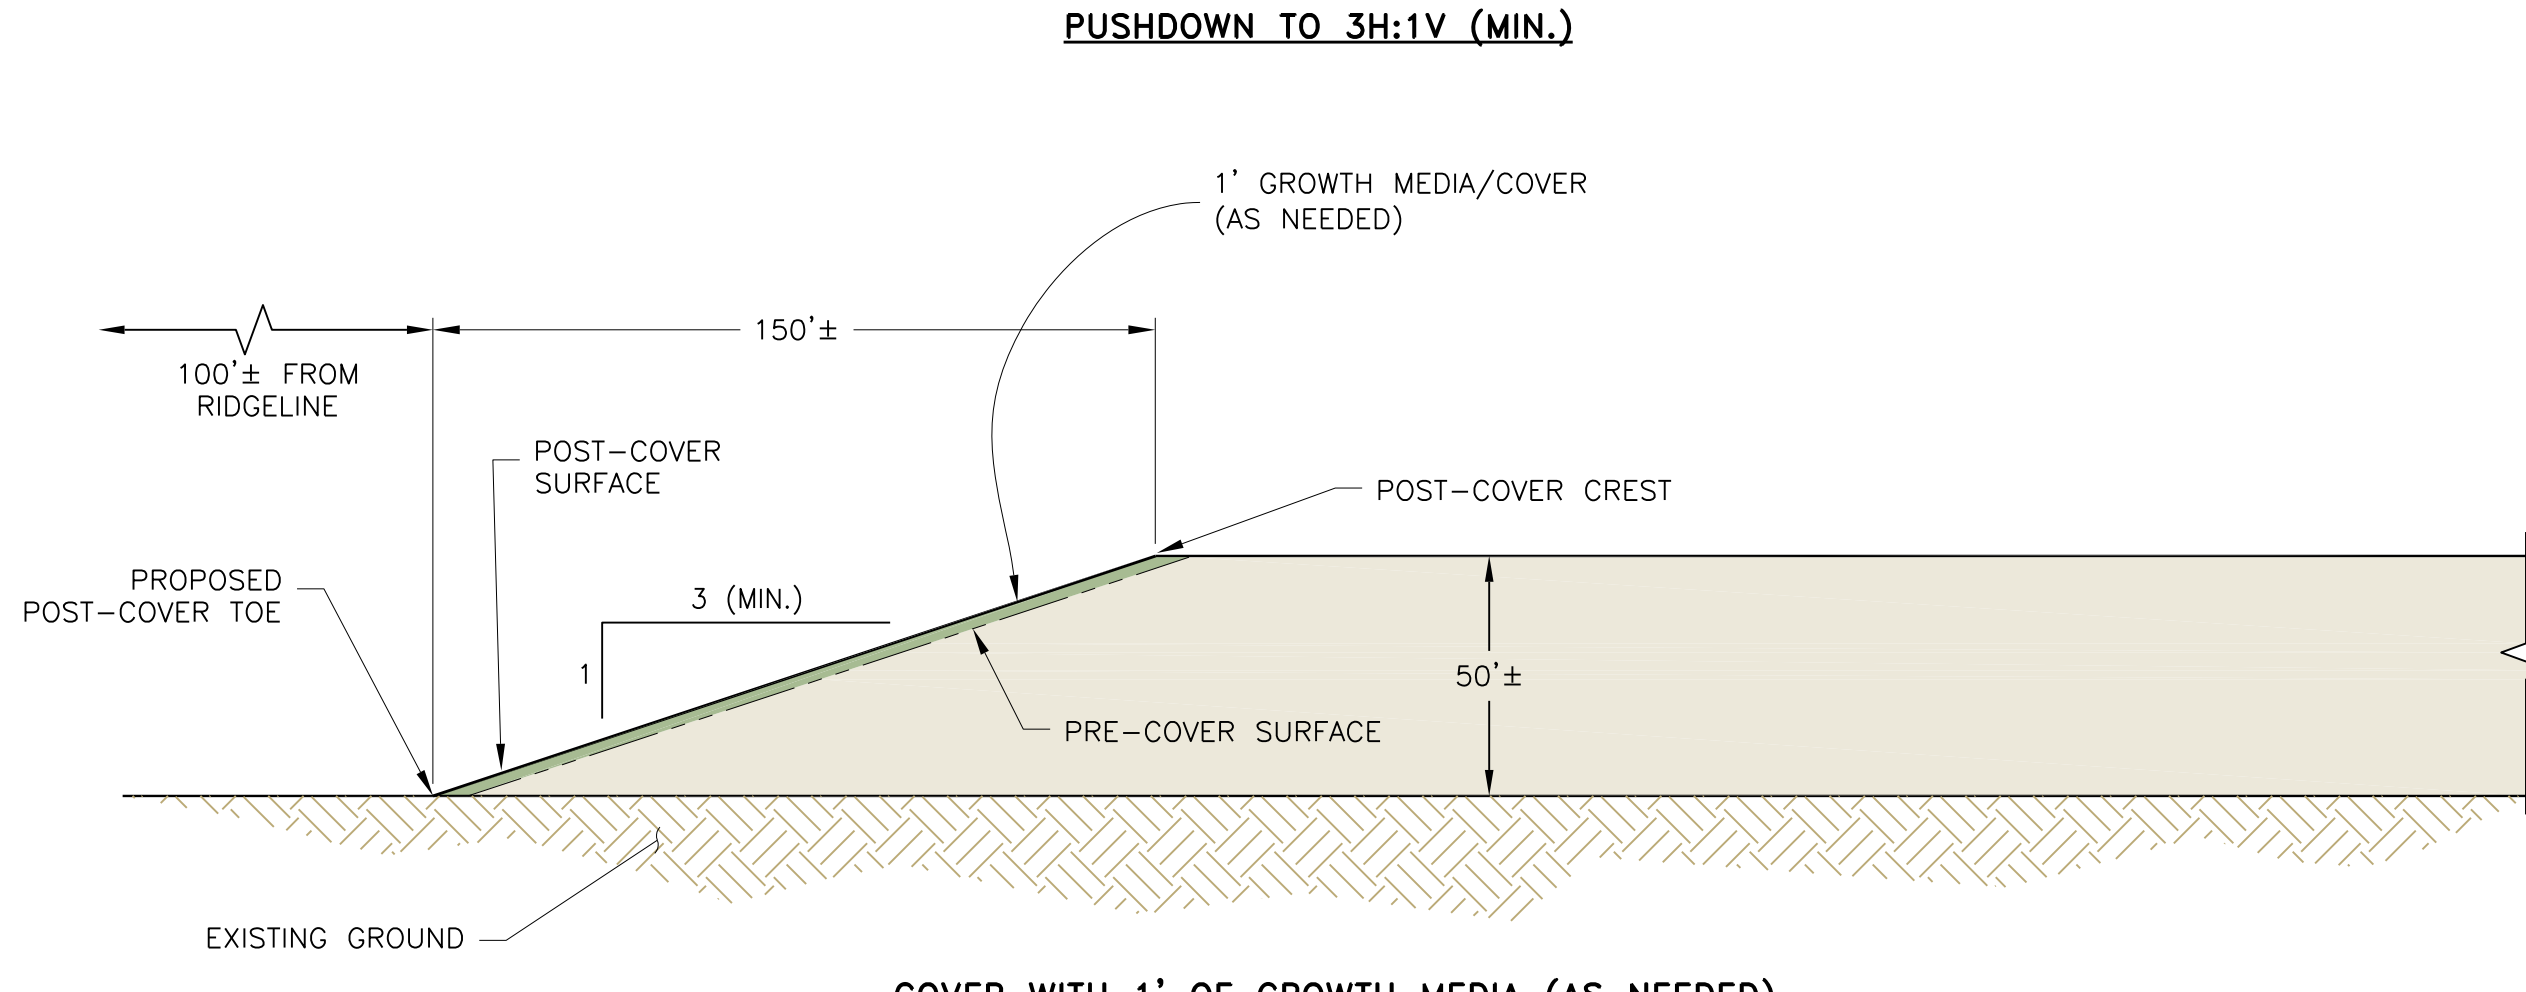
PUSHDOWN TO 3H:1V (MIN.)

COVER WITH 1' OF GROWTH MEDIA (AS NEEDED)

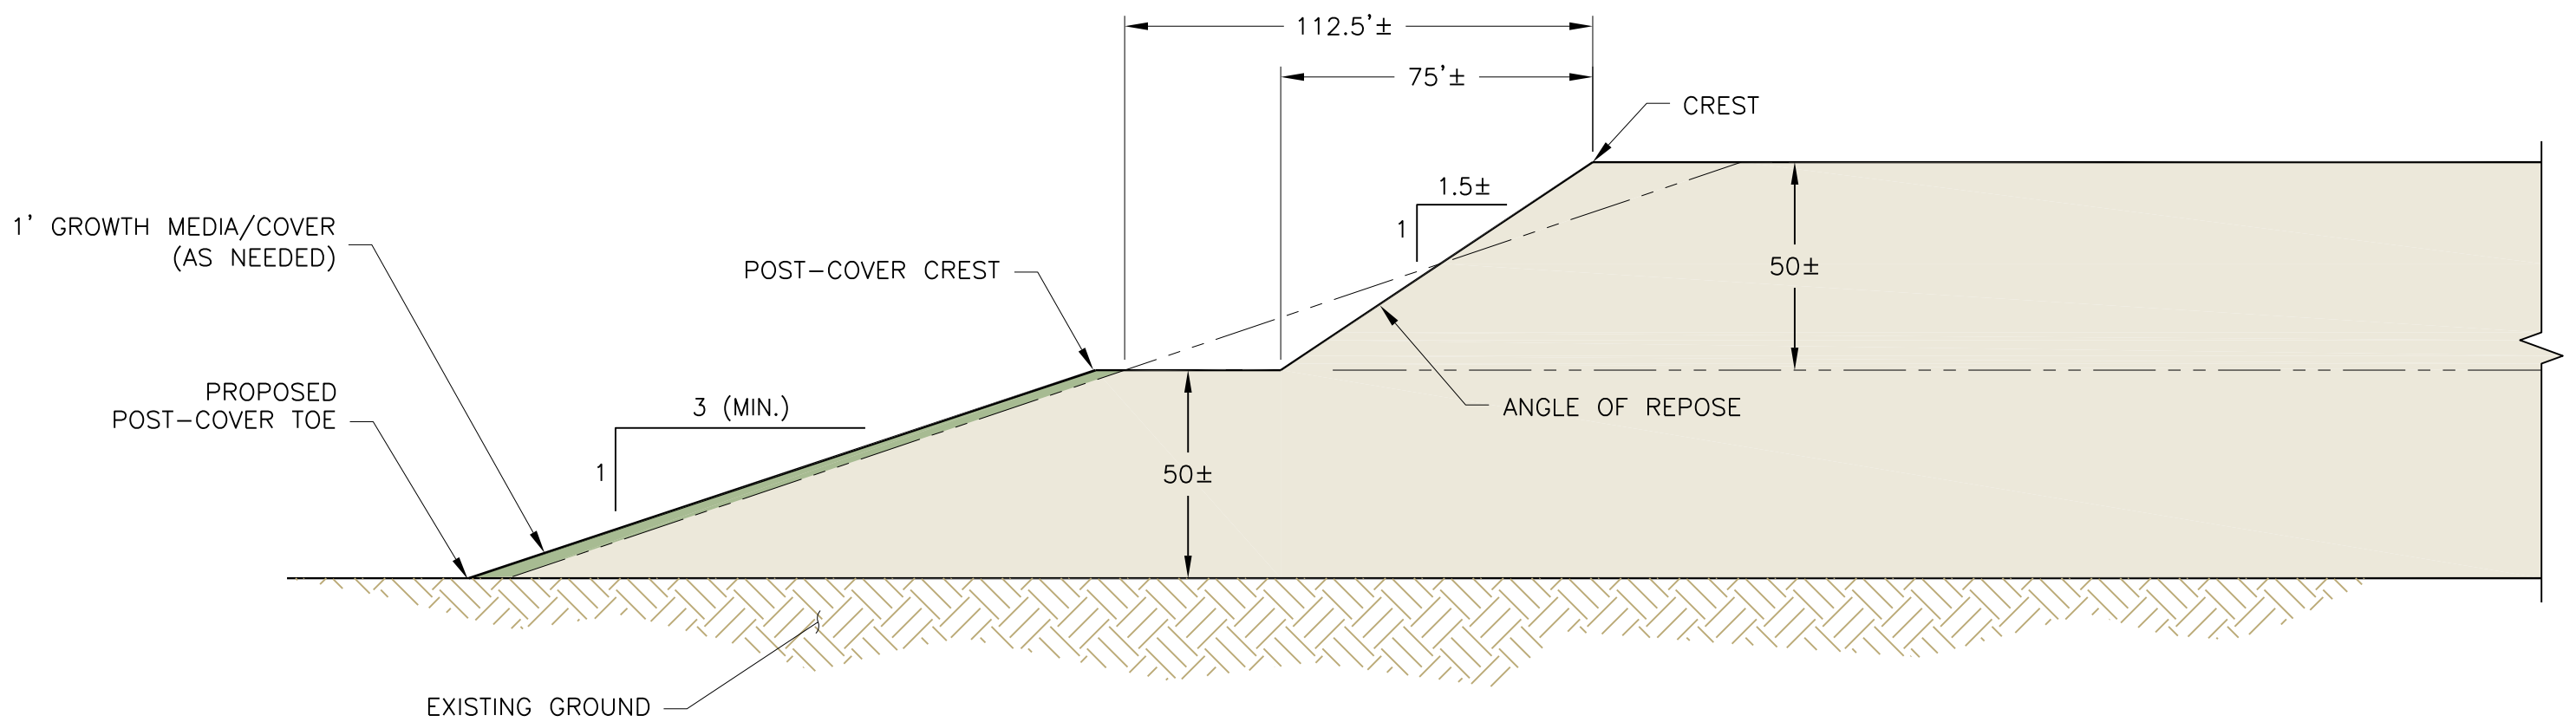
BEGIN 2ND LIFT

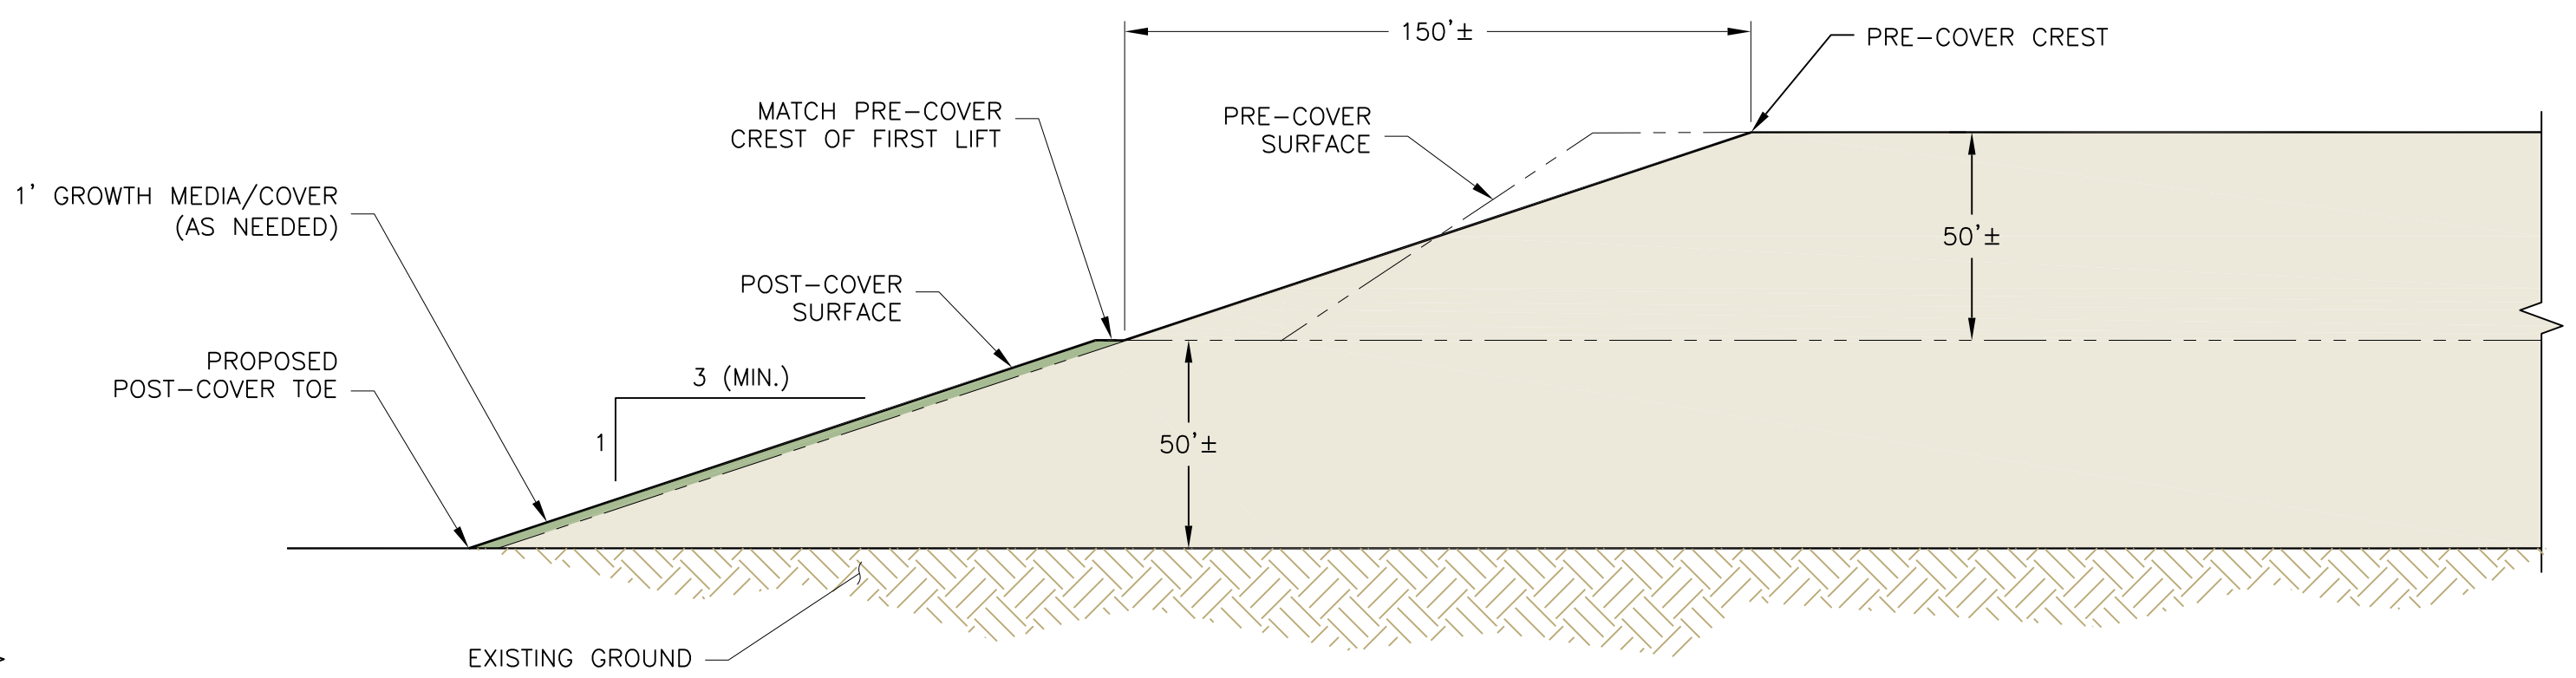
PUSH DOWN 2ND LIFT TO 3H:1V (MIN.)

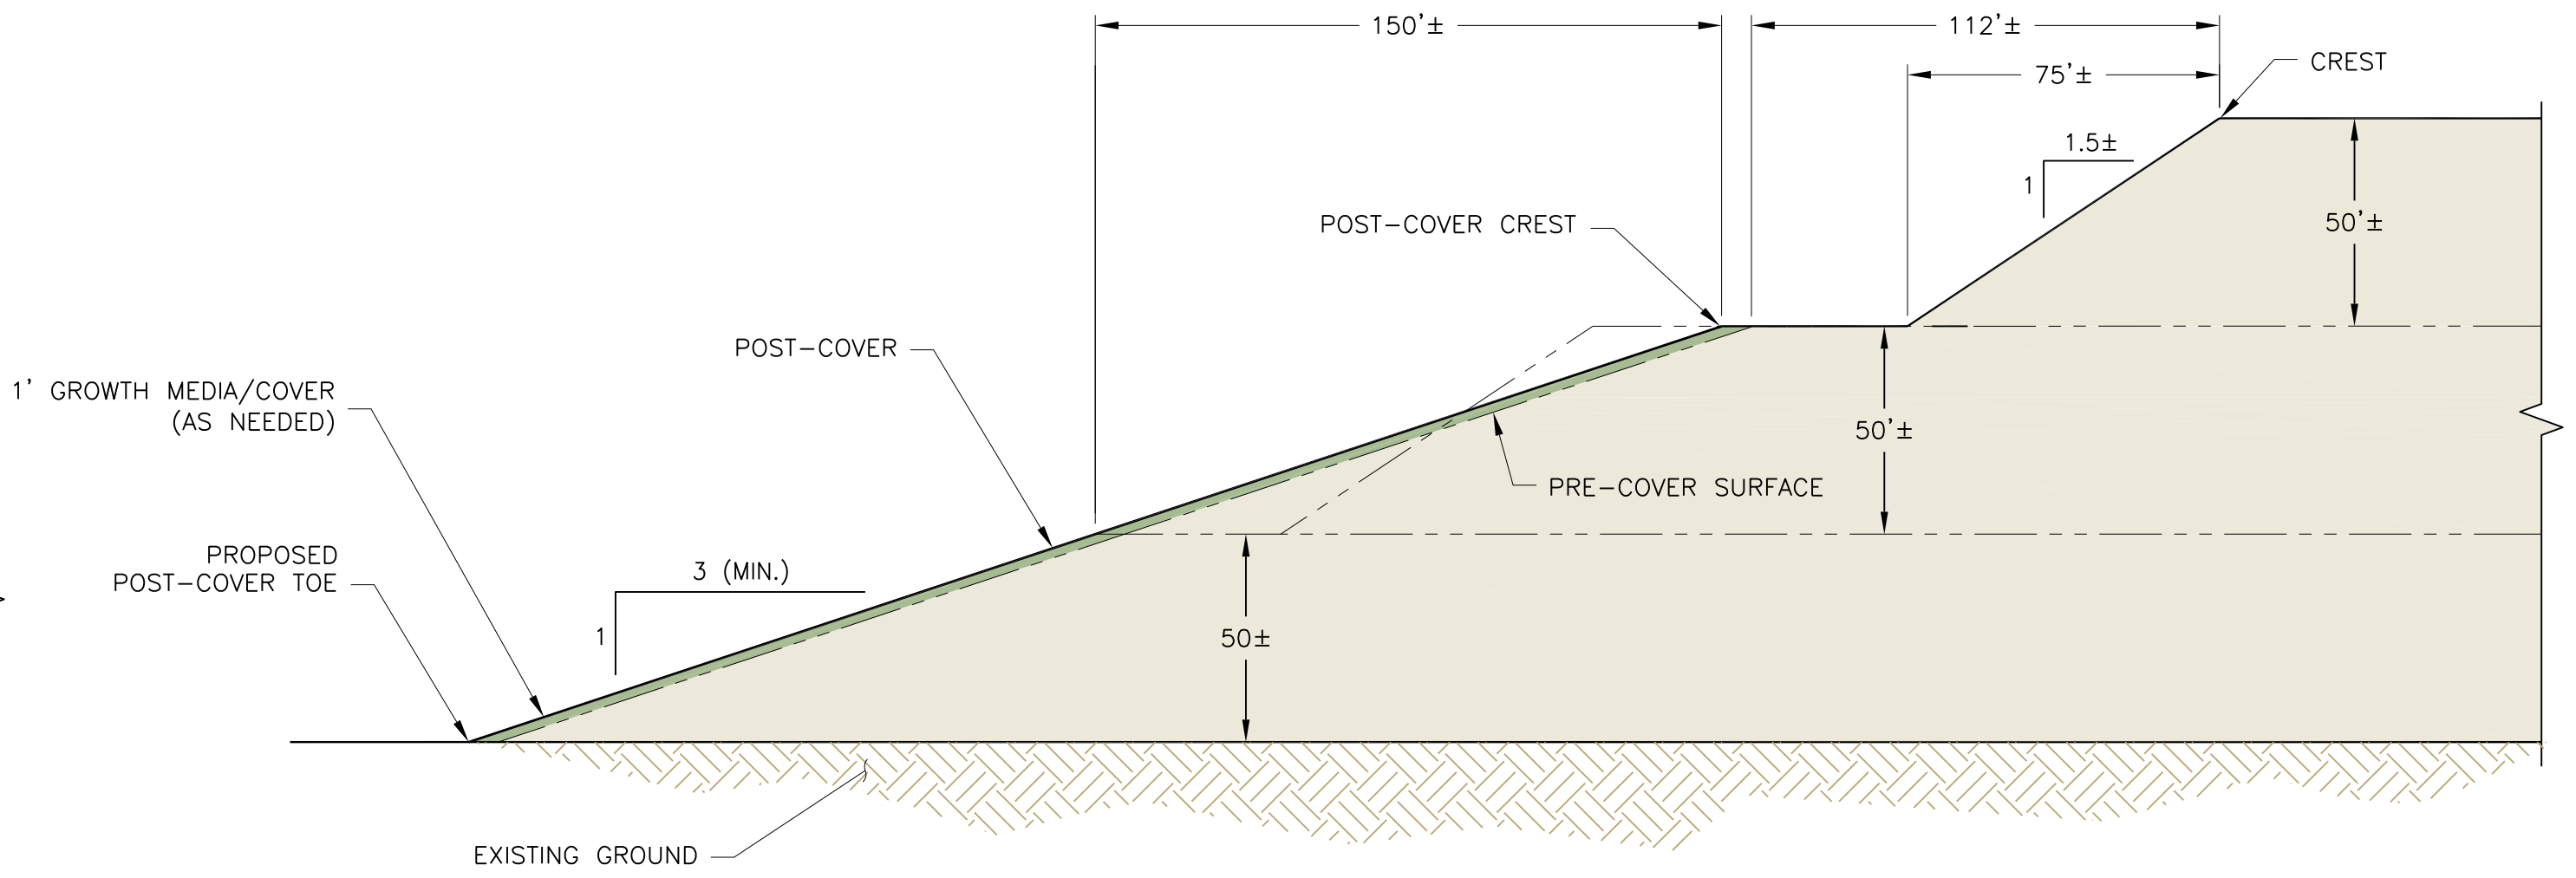
ADD GROWTH MEDIA AS NEEDED TO GRADED 2ND LIFT AND BEGIN 3RD LIFT
